Inspection Report

Property Address:
103 W Dee Street
Memphis TN 38000

General Summary

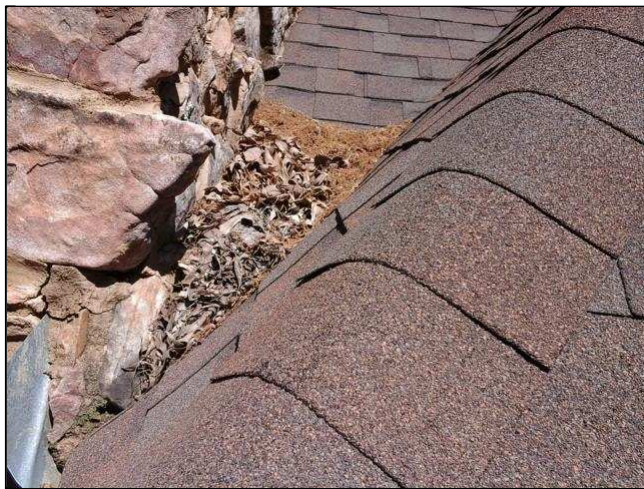
1.0 Item 1(Picture)

The roof covering has leaves and debris in valleys at the front of home. This area will need periodical maintenance. Recommend cleaning debris from roof, valleys and gutter systems..

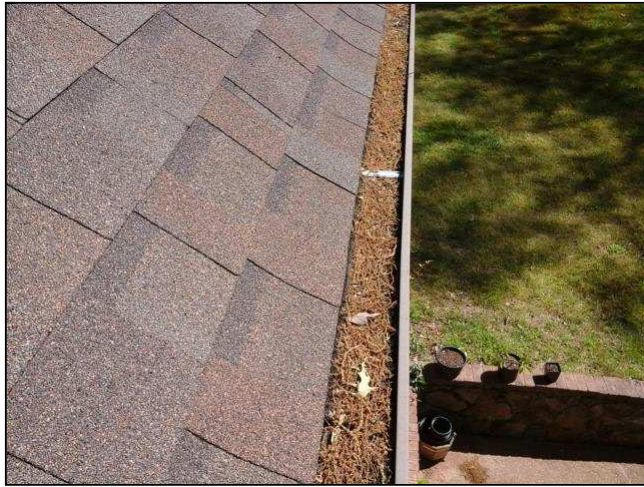
1.3 Item 1(Picture)

Debris visible in the gutters at the time of the inspection should be removed to encourage proper drainage.

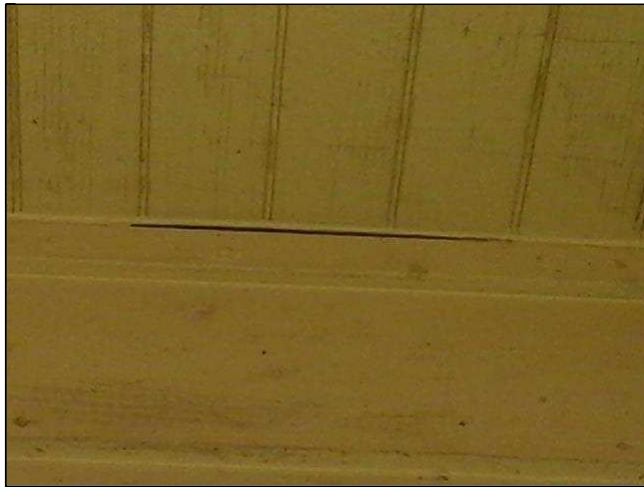
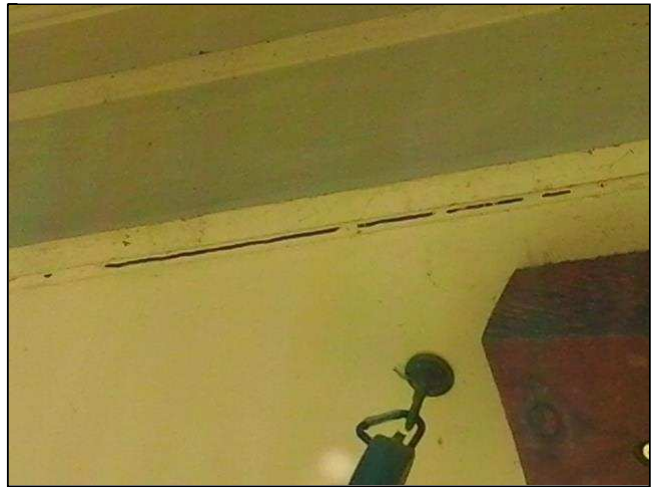
3.0 Item 1(Picture)

(1) The wood trim at eave on the exterior in areas gaps in caulking. Deterioration may occur if not corrected. I recommend repair or replace as required.

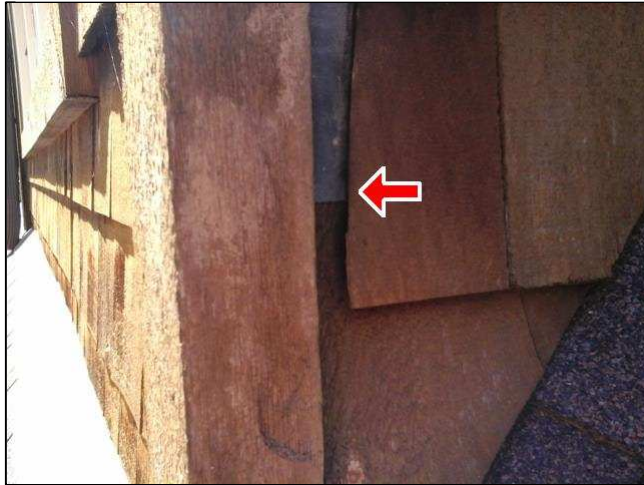
3.0 Item 3(Picture)

(2) The Wood siding at the front of home damaged. Deterioration can eventually occur if not corrected. I recommend repair or replace as required.

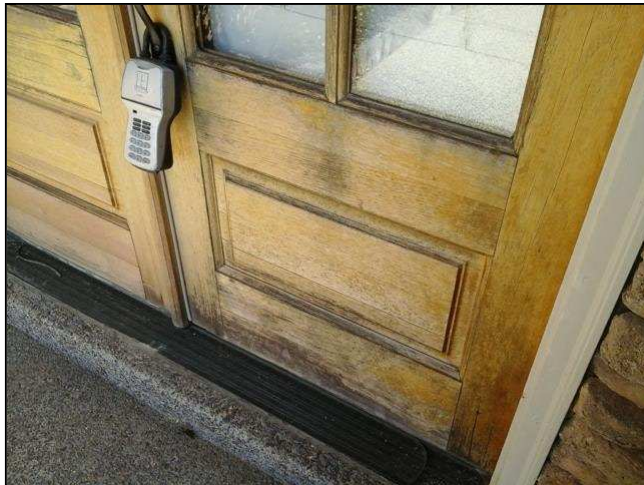
3.2 Item 1(Picture)

The main entry door weathered and needs prep and paint (exterior)

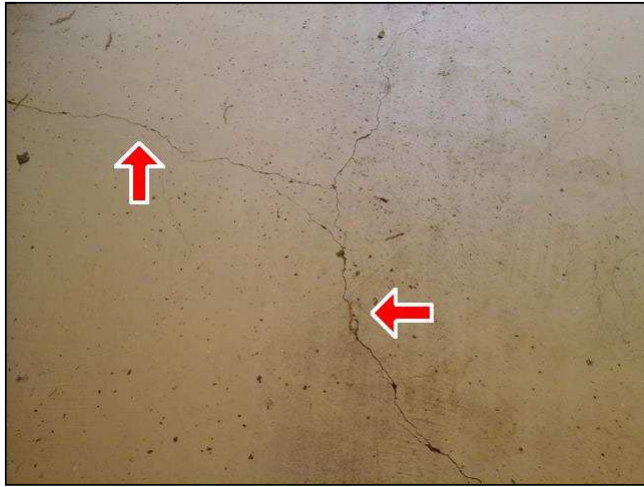
4.2 Item 1(Picture)

The garage floor had common shrinkage cracks. These cracks are not a structural concern.

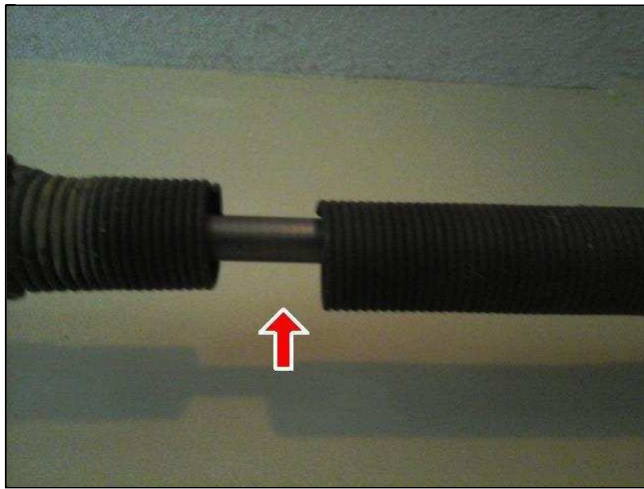
4.3 Item 1(Picture)

The garage door at the left side (facing front) coil spring is damaged. Recommend repair or replace as required.

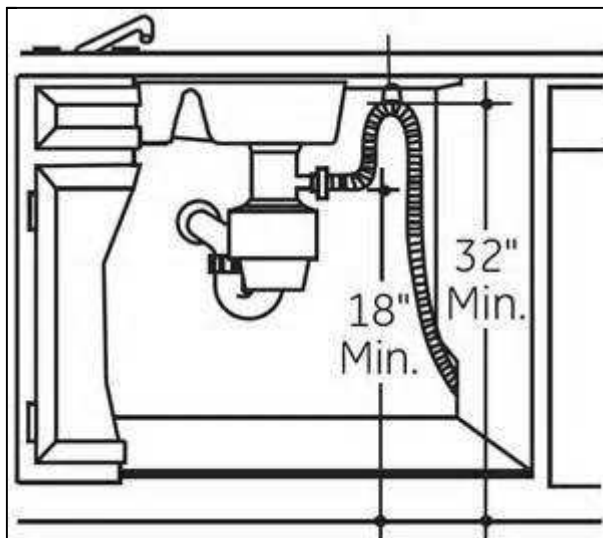
5.0 Item 1(Picture)

The dishwasher drain hose did not perform a loop to create a trap under sink. I recommend repair as necessary.

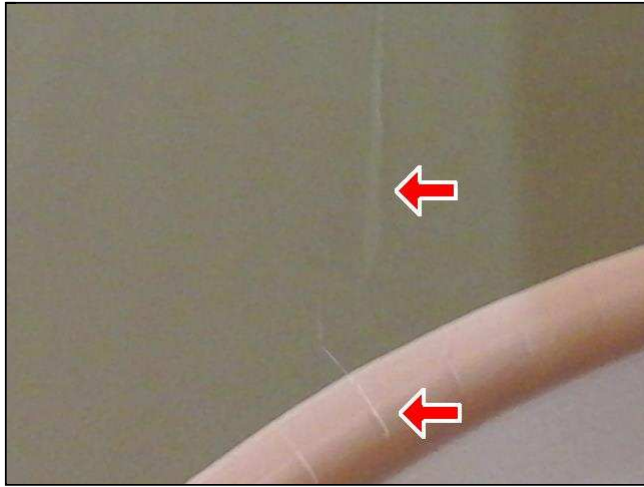
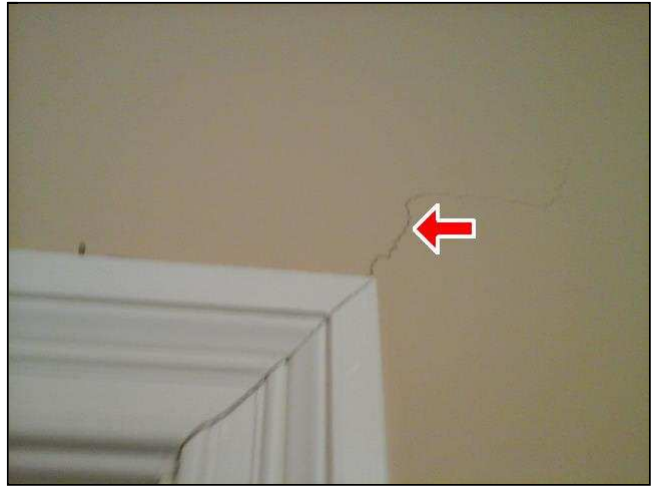
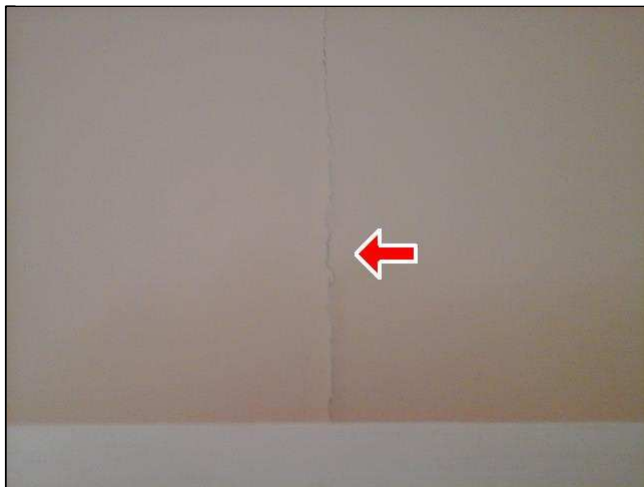
6.1 Item 1(Picture)

(1) Observed settling cracks on sheetrock walls at following locations:

- Dining Room
- Upstairs office/bedroom
- Bedroom toward rear of home.

This damage is considered cosmetic.

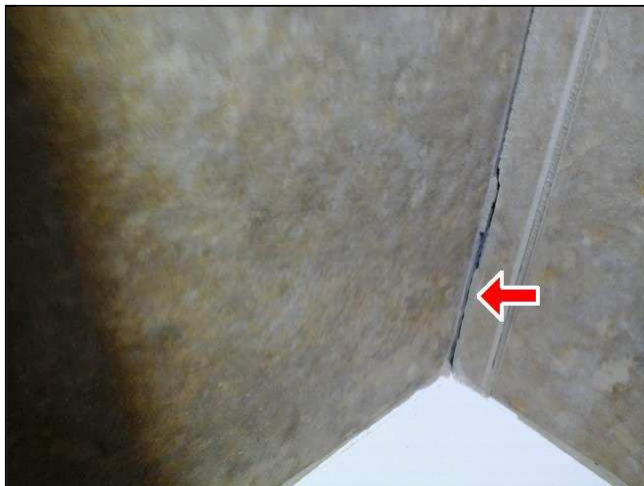
6.1 Item 4(Picture)

(2) The tile tub surround has gaps in grout at the downstairs Private Bath. Repairs are needed. .

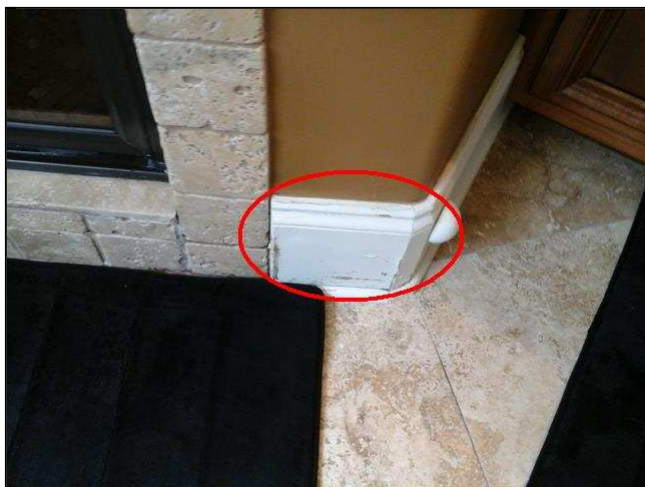
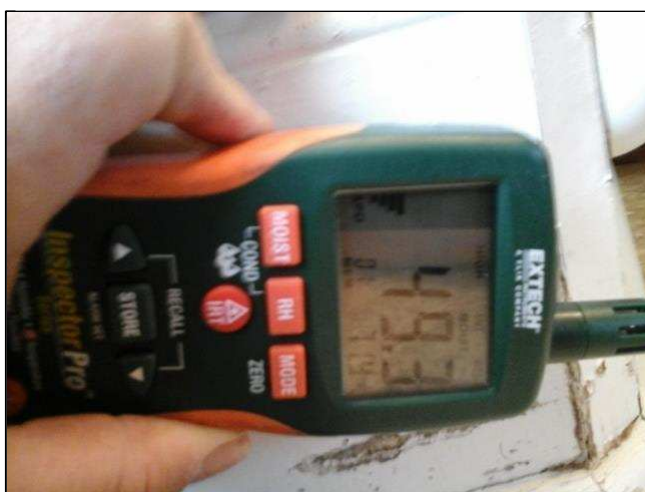
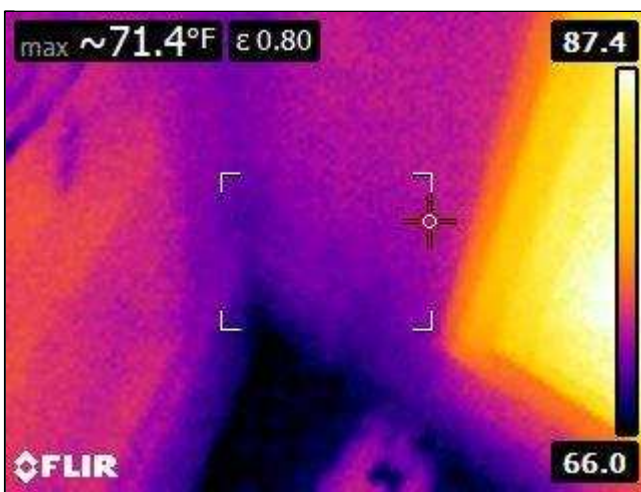
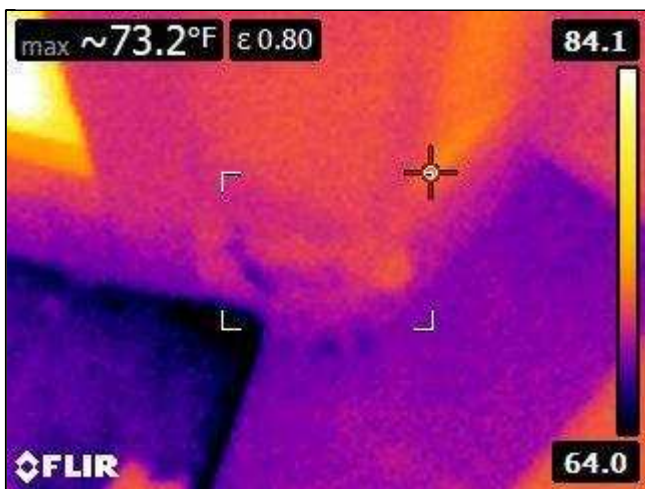
6.1 Item 5(Picture)

(3) The baseboard on the wall shows wet stains indicating moisture or intrusion did or still may occur at the Master bath. The moisture meter was used and it recorded 19% or higher, which indicates the leak has not been corrected. A qualified contractor should inspect and repair as needed.

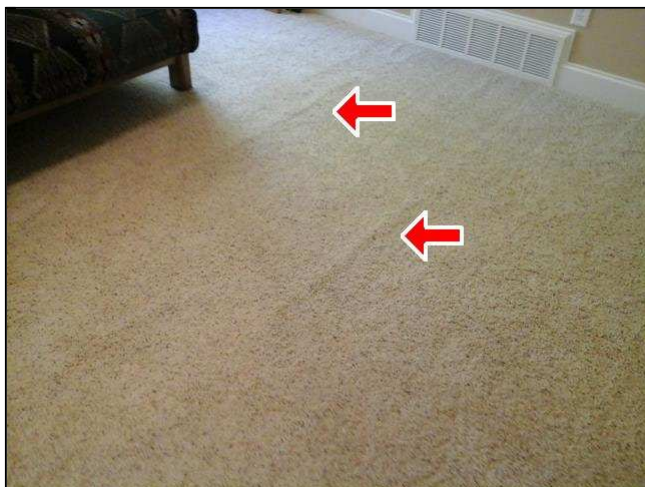
6.2 Item 1(Picture)

(1) The Carpet is loose or baggy and not stretched for a tight installation at the Bedroom. This damage is considered cosmetic. .

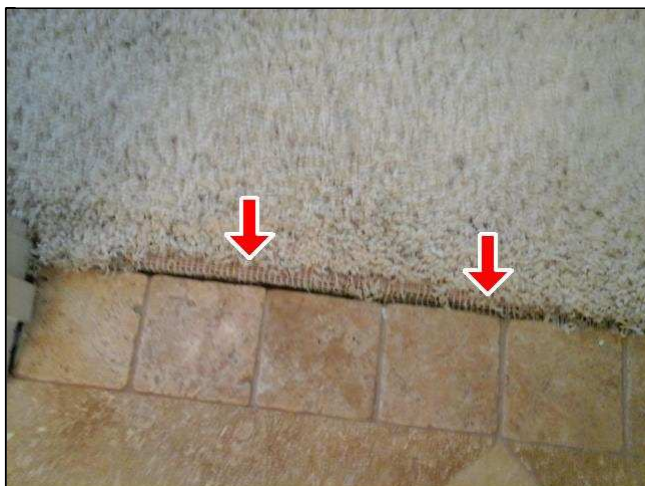
6.2 Item 2(Picture)

(2) The Carpet is damaged at the Master Bedroom. Repairs are needed. .

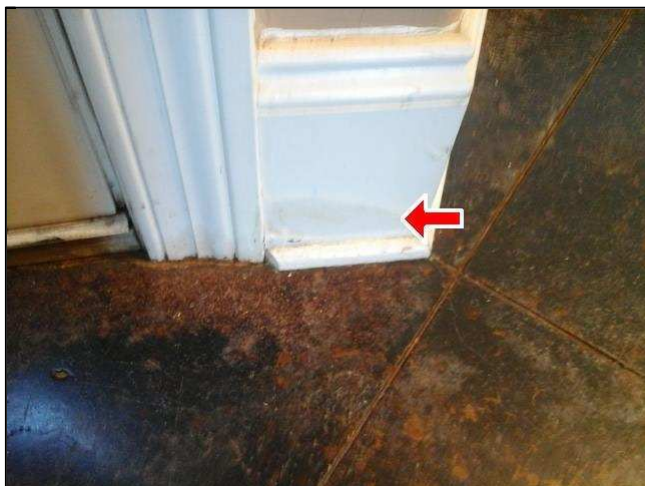
6.3 Item 1(Picture)

Moisture was detected with Thermal Imaging at rear entrance on baseboard. Recommend qualified contractor further inspect and repair as needed.

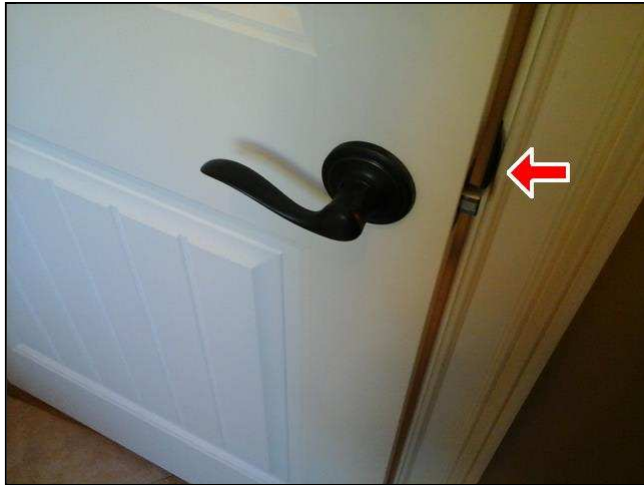
6.6 Item 1(Picture)

The Entry door needs strike and latch adjustment to shut tight at the Laundry. A repair or adjustment is needed. .

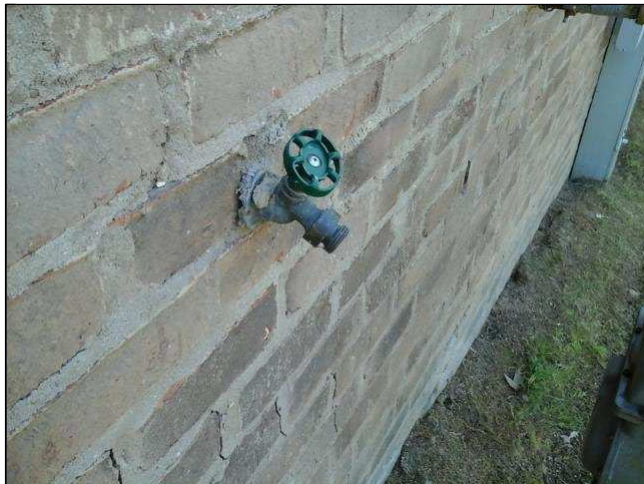
7.1 Item 1(Picture)

The hose bib did not work at the left side (facing front). Recommend qualified contractor further review and repair as needed.

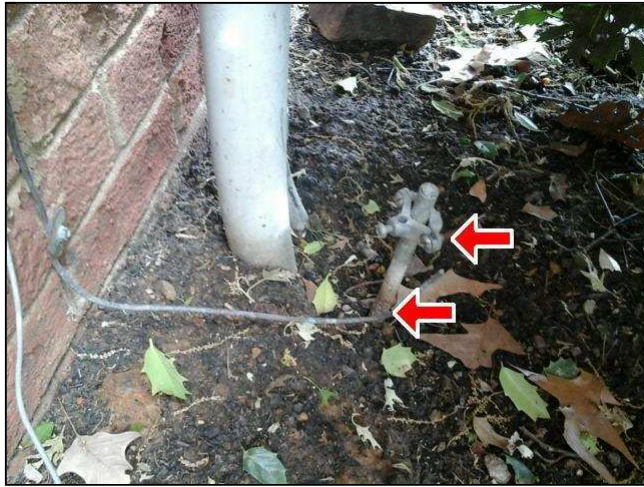
8.2 Item 1(Picture)

A ground wire to ground rod is present at meter base, but the wire is no longer attached to ground rod. Electrical issues are considered a hazard until repaired. I recommend repair as needed.

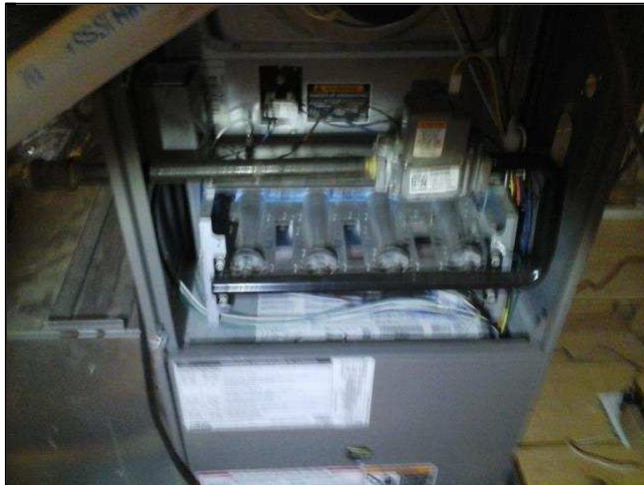
9.0.C Item 1(Picture)

The gas furnace will fire, but shuts off prematurely. A more thorough inspection by a qualified contractor is needed.

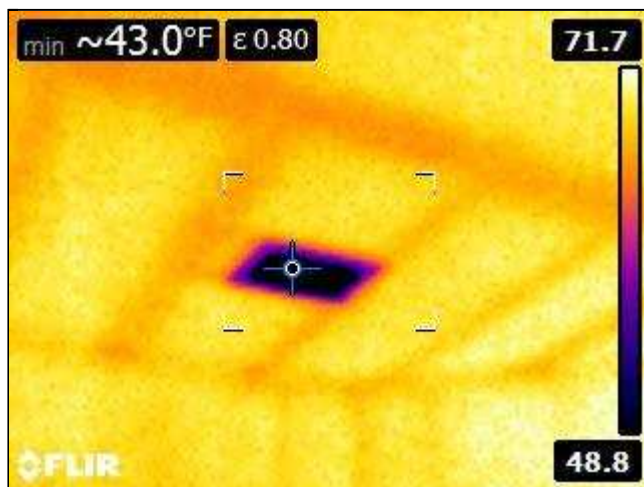
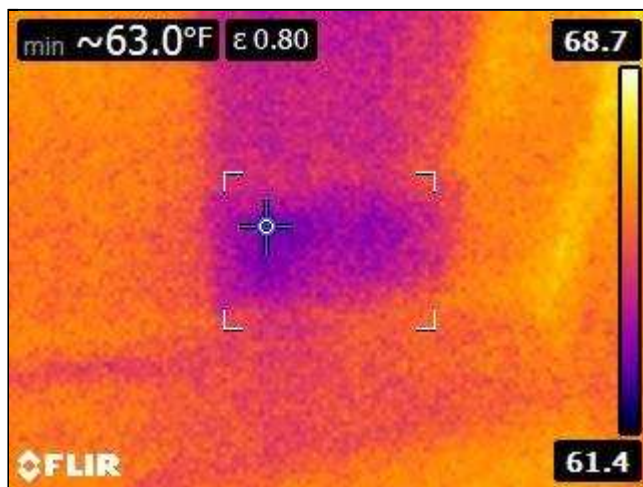
10.0.A Item 1(Picture)

The ambient air test was performed by using thermometers on the air handler of Air conditioner to determine if the difference in temperatures of the supply and return air are between 14 degrees and 22 degrees which indicates that the unit is cooling as intended. The supply air temperature on your system read 43 degrees, and the return air temperature was 63 degrees. This indicates the range in temperature drop is normal.

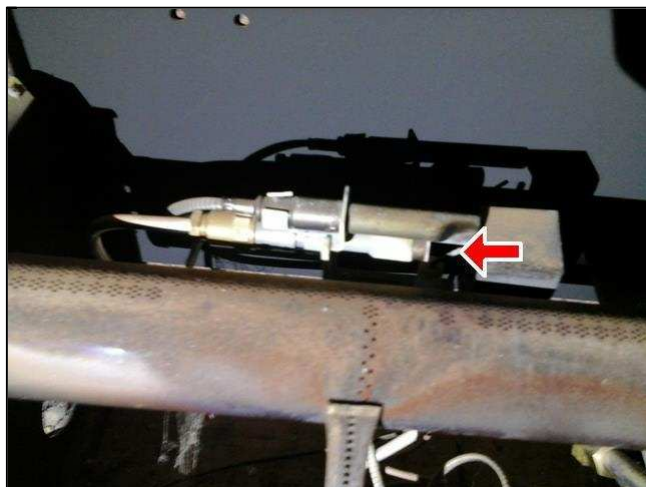
11.1 Item 1(Picture)

The pilot igniter for non-vented gas logs was not working at time of inspection. Recommend repair or replace as needed.

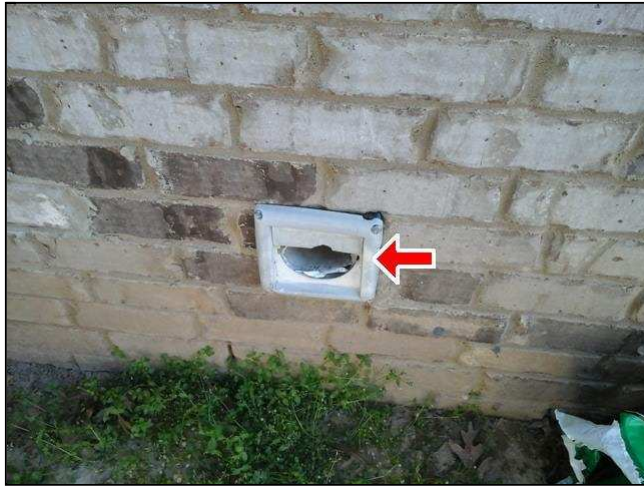
12.2 Item 1(Picture)

The dryer vent is damaged. Allowing rodents to enter. I recommend repair as needed.

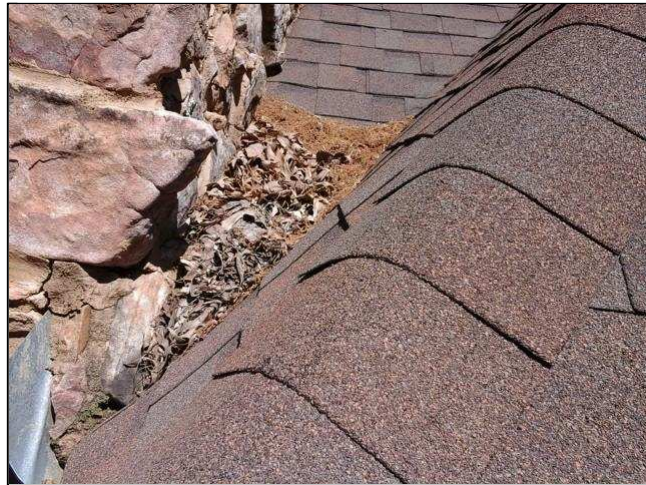
1.0 Item 1(Picture)

The roof covering has leaves and debris in valleys at the front of home. This area will need periodical maintenance. Recommend cleaning debris from roof, valleys and gutter systems..

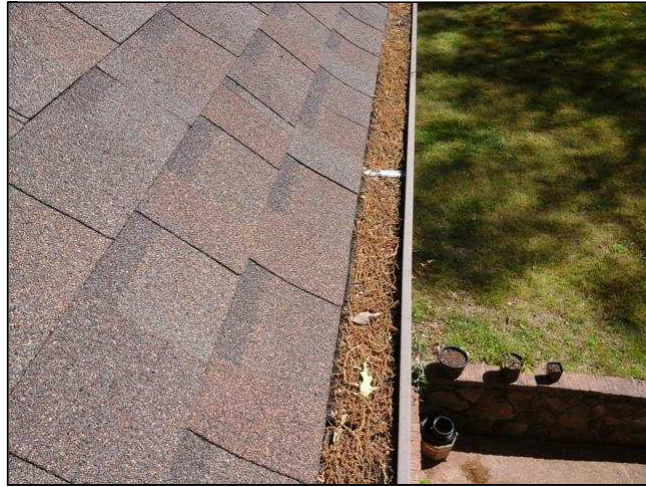
1.3 Item 1(Picture)

Debris visible in the gutters at the time of the inspection should be removed to encourage proper drainage.

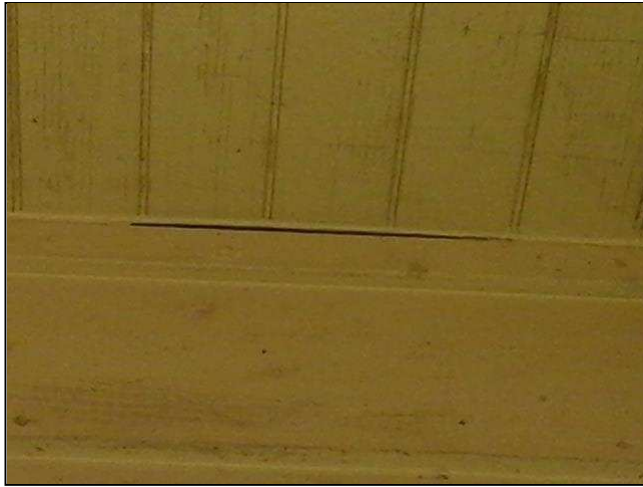
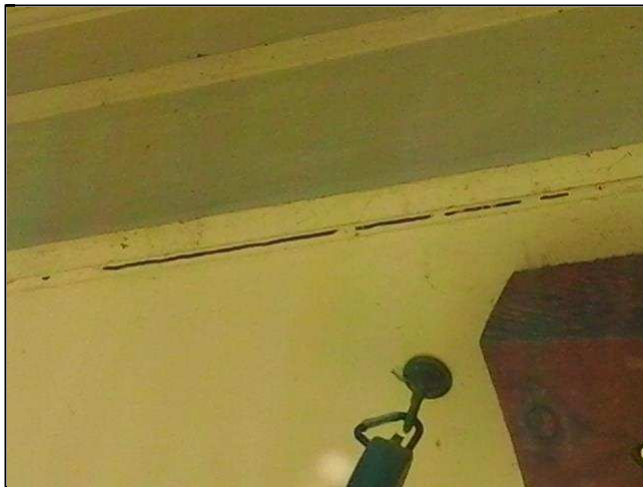
3.0 Item 1(Picture)

(1) The wood trim at eave on the exterior in areas gaps in caulking. Deterioration may occur if not corrected. I recommend repair or replace as required.

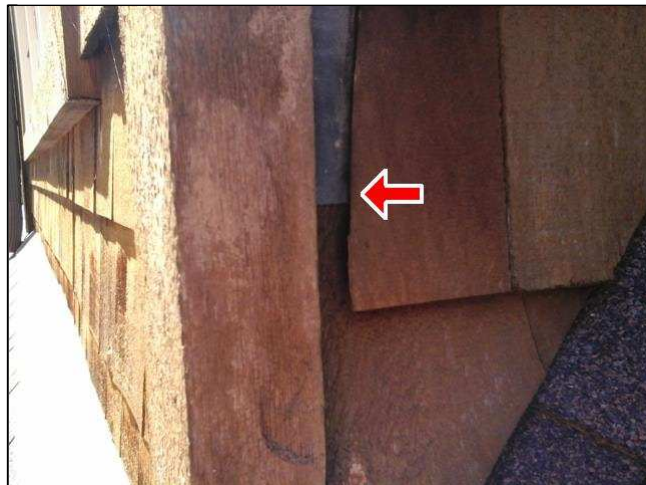
3.0 Item 3(Picture)

(2) The Wood siding at the front of home damaged. Deterioration can eventually occur if not corrected. I recommend repair or replace as required.

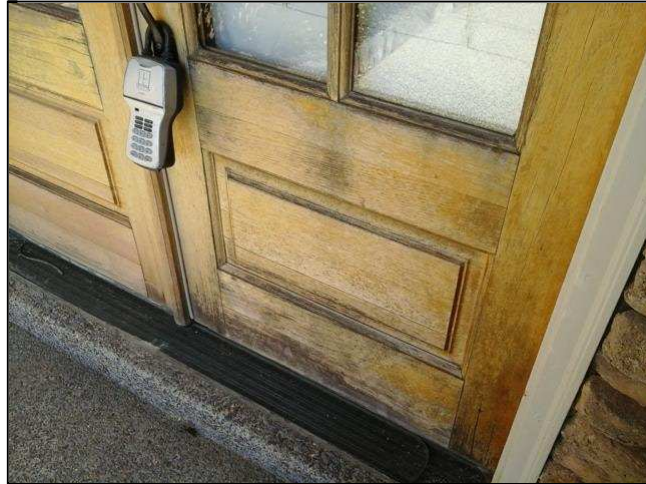
3.2 Item 1(Picture)

The main entry door weathered and needs prep and paint (exterior)

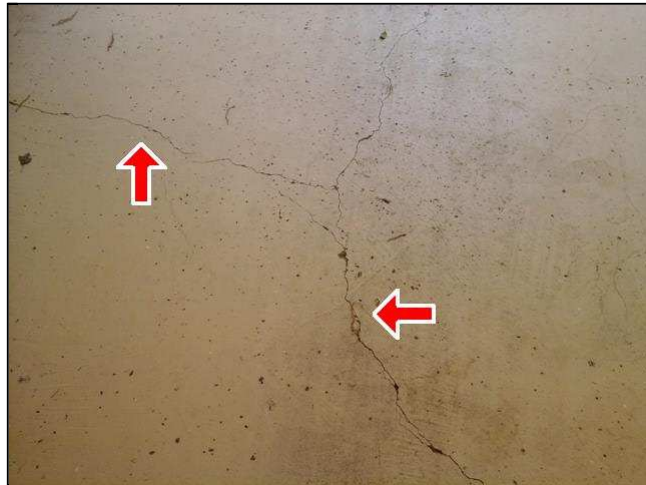
4.2 Item 1(Picture)

The garage floor had common shrinkage cracks. These cracks are not a structural concern.

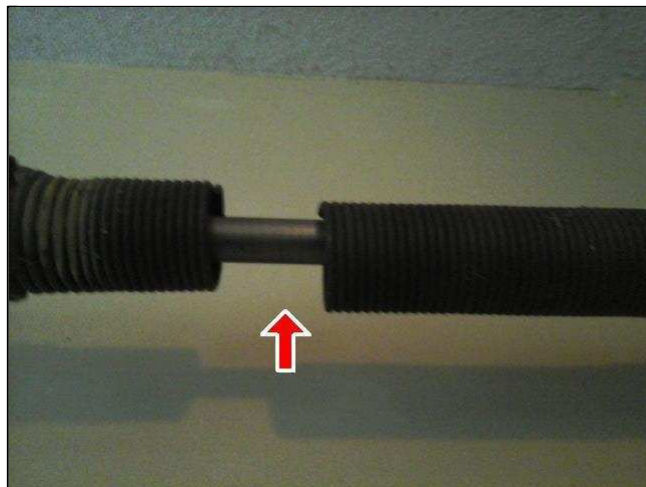
4.3 Item 1(Picture)

The garage door at the left side (facing front) coil spring is damaged. Recommend repair or replace as required.

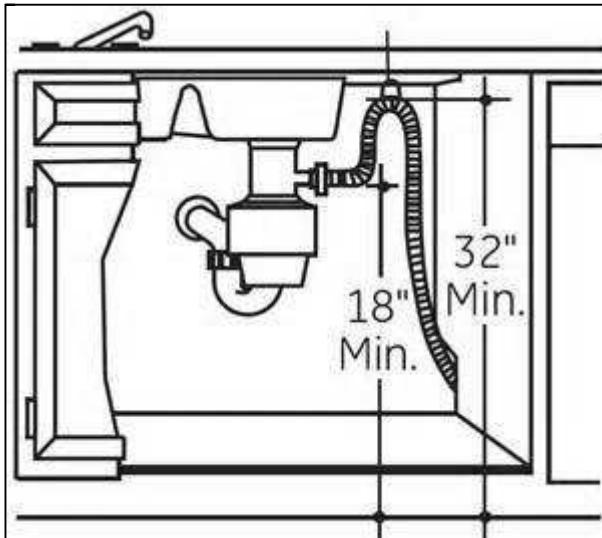
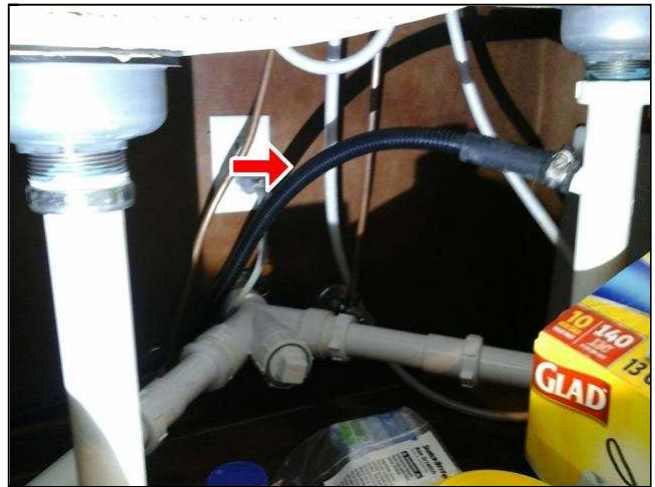
5.0 Item 1(Picture)

The dishwasher drain hose did not perform a loop to create a trap under sink. I recommend repair as necessary.

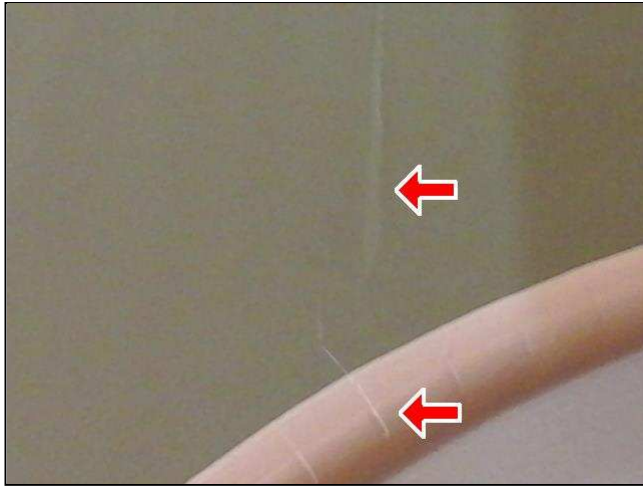
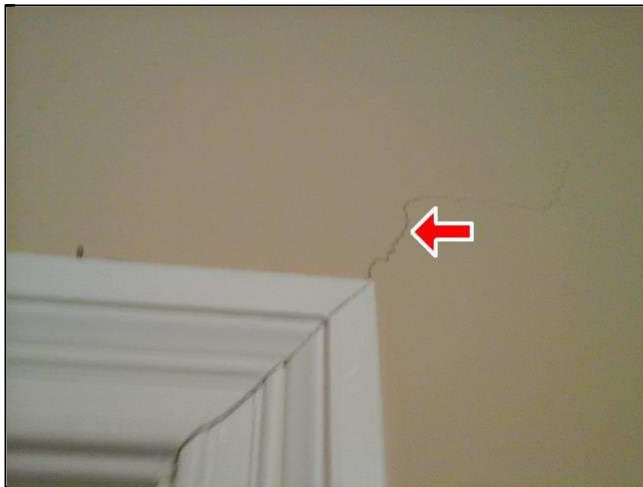
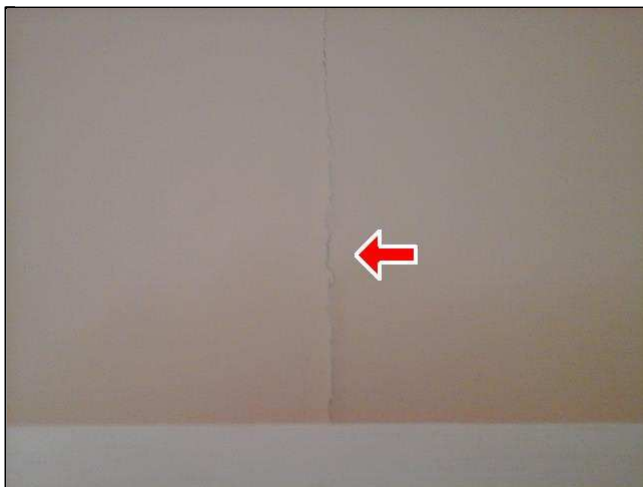
6.1 Item 1(Picture)

(1) Observed settling cracks on sheetrock walls at following locations:

- Dining Room
- Upstairs office/bedroom
- Bedroom toward rear of home.

This damage is considered cosmetic.

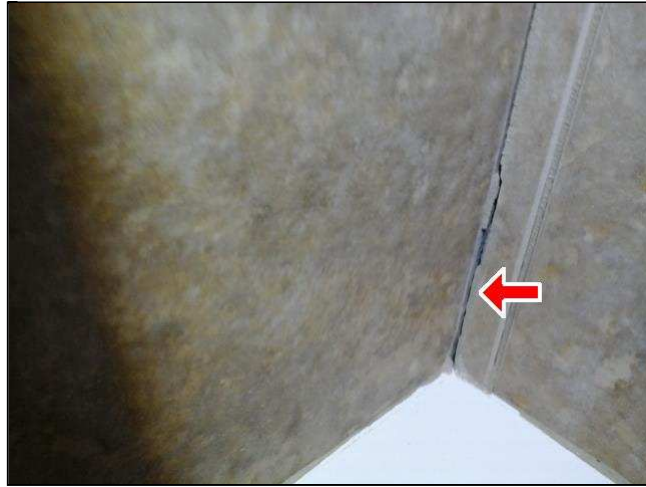
6.1 Item 4(Picture)

(2) The tile tub surround has gaps in grout at the downstairs Private Bath. Repairs are needed. .

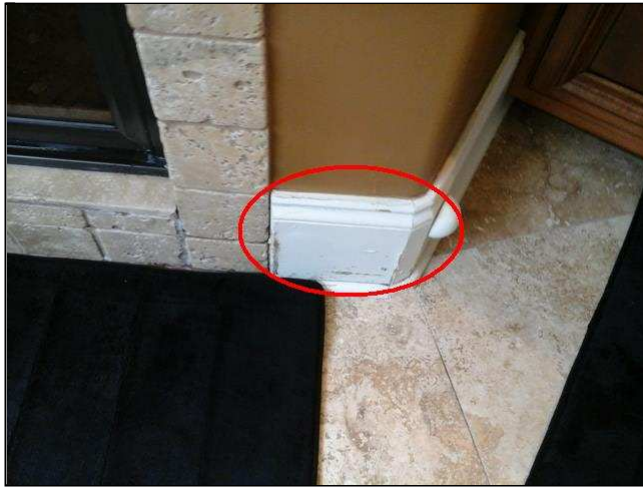
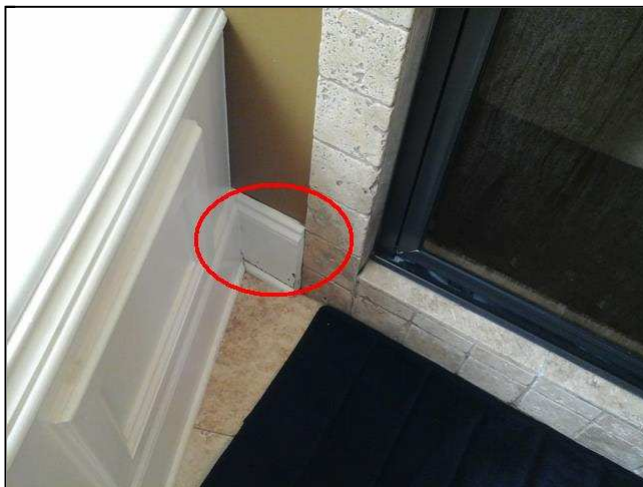
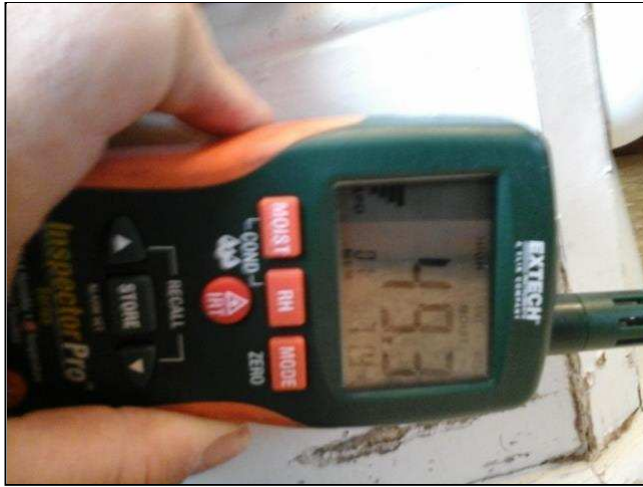
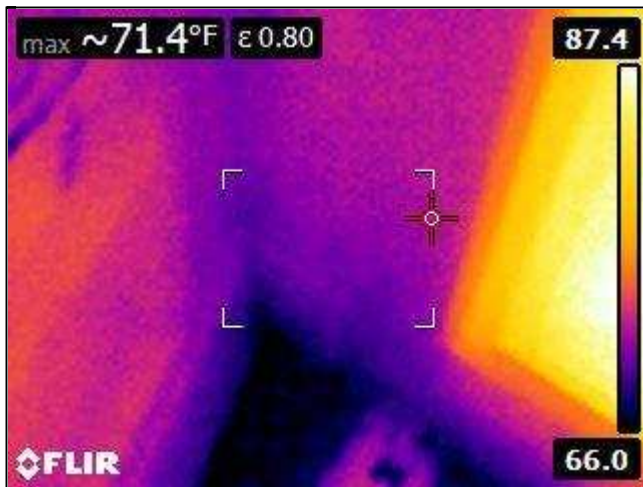
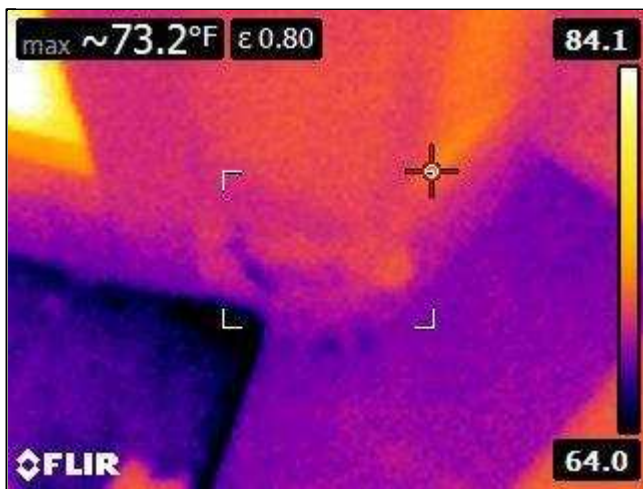
6.1 Item 5(Picture)

(3) The baseboard on the wall shows wet stains indicating moisture or intrusion did or still may occur at the Master bath. The moisture meter was used and it recorded 19% or higher, which indicates the leak has not been corrected. A qualified contractor should inspect and repair as needed.

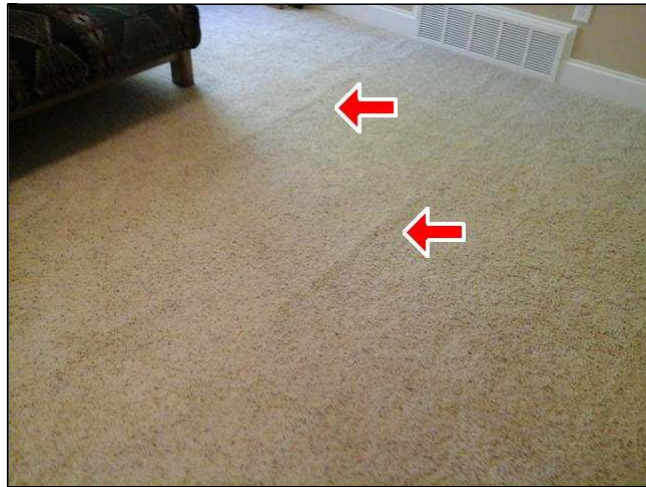
6.2 Item 1(Picture)

(1) The Carpet is loose or baggy and not stretched for a tight installation at the Bedroom. This damage is considered cosmetic. .

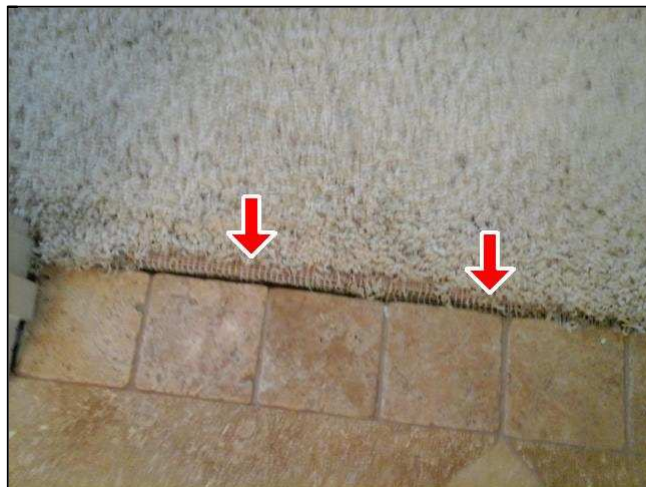
6.2 Item 2(Picture)

(2) The Carpet is damaged at the Master Bedroom. Repairs are needed.

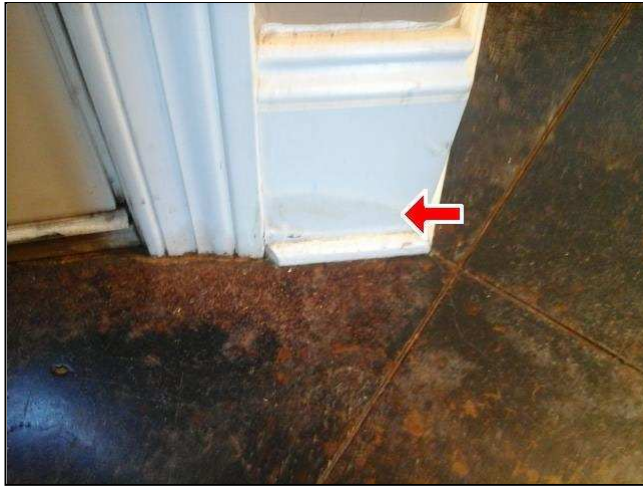
6.3 Item 1(Picture)

Moisture was detected with Thermal Imaging at rear entrance on baseboard. Recommend qualified contractor further inspect and repair as needed.

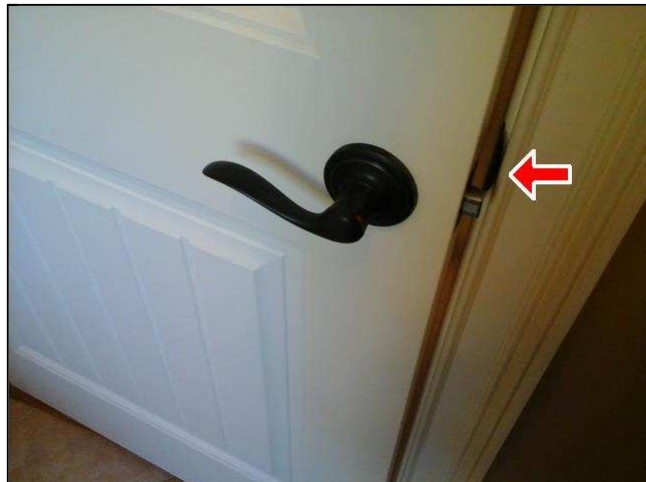
6.6 Item 1(Picture)

The Entry door needs strike and latch adjustment to shut tight at the Laundry. A repair or adjustment is needed. .

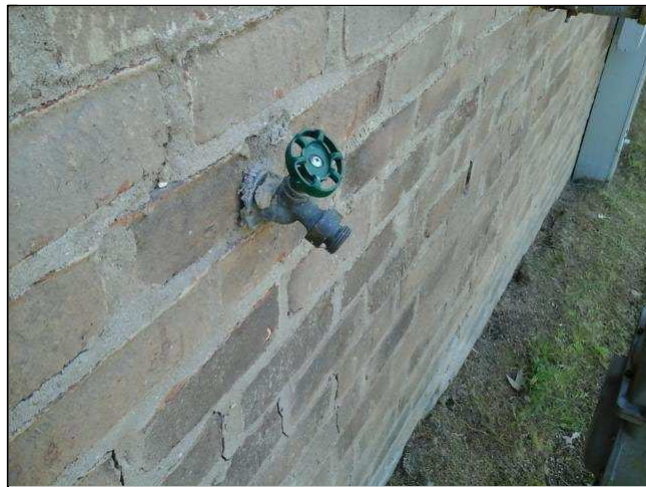
7.1 Item 1(Picture)

The hose bib did not work at the left side (facing front). Recommend qualified contractor further review and repair as needed.

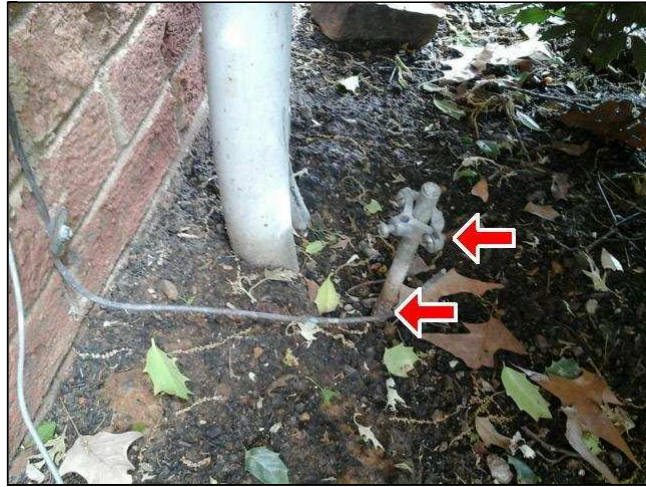
8.2 Item 1(Picture)

A ground wire to ground rod is present at meter base, but the wire is no longer attached to ground rod. Electrical issues are considered a hazard until repaired. I recommend repair as needed.

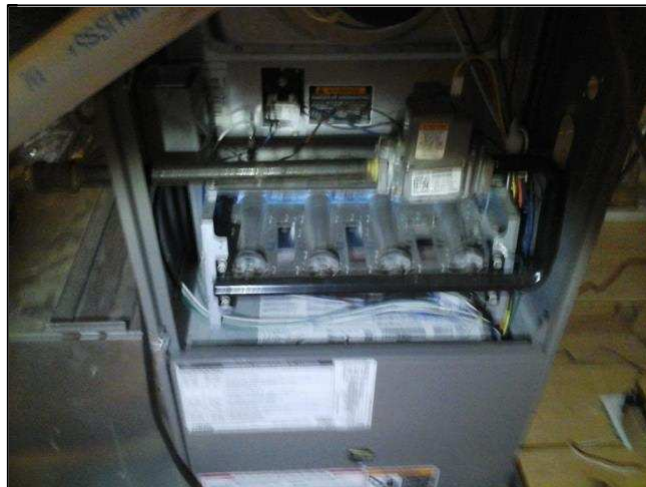
9.0.C Item 1(Picture)

The gas furnace will fire, but shuts off prematurely. A more thorough inspection by a qualified contractor is needed. .

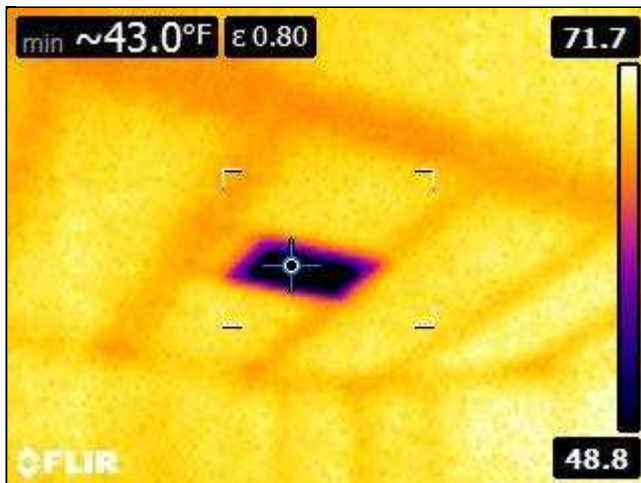
10.0.A Item 1(Picture)

The ambient air test was performed by using thermometers on the air handler of Air conditioner to determine if the difference in temperatures of the supply and return air are between 14 degrees and 22 degrees which indicates that the unit is cooling as intended. The supply air temperature on your system read 43 degrees, and the return air temperature was 63 degrees. This indicates the range in temperature drop is normal.

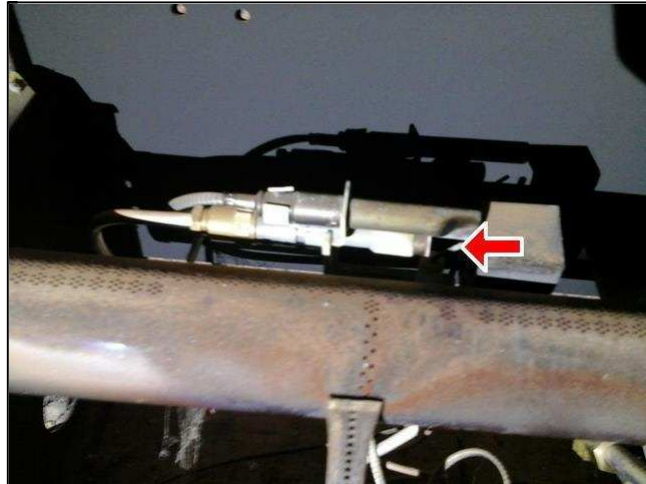
11.1 Item 1(Picture)

The pilot igniter for non-vented gas logs was not working at time of inspection. Recommend repair or replace as needed.

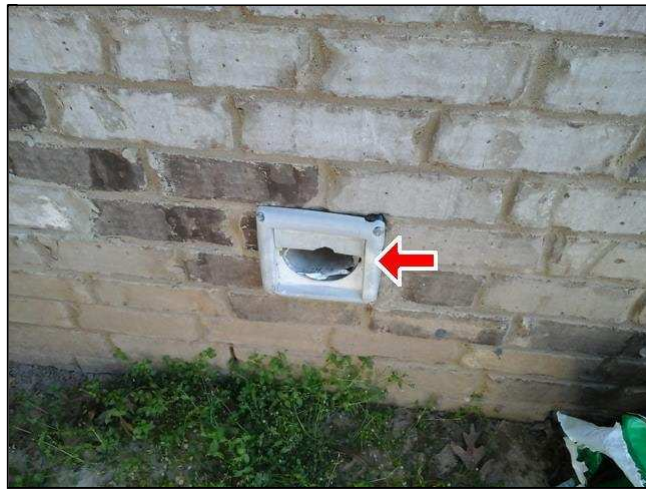
12.2 Item 1(Picture)

The dryer vent is damaged. Allowing rodents to enter. I recommend repair as needed.
